Manhole Inspection Summary

Manhole # S07CC2016MH

Location Address: **2800 BERKELEY AVE**

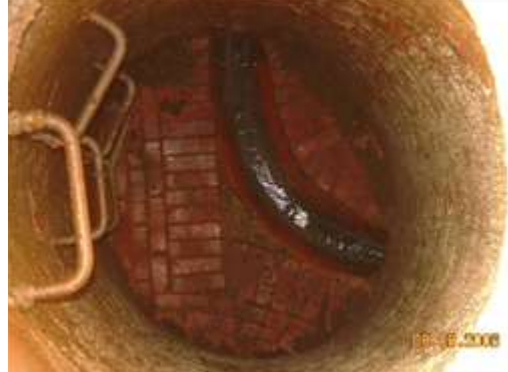
Top View

Adjustment, Corbel and Barrel infiltration.

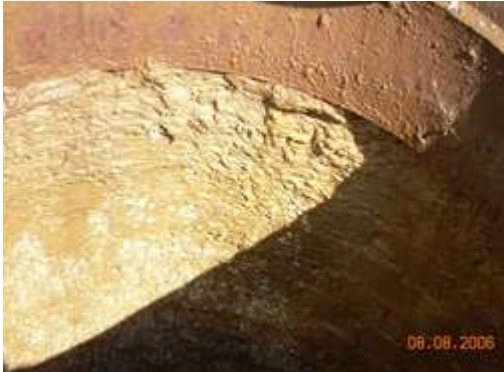
Defect

Frame leaks. Adjustment infiltration.

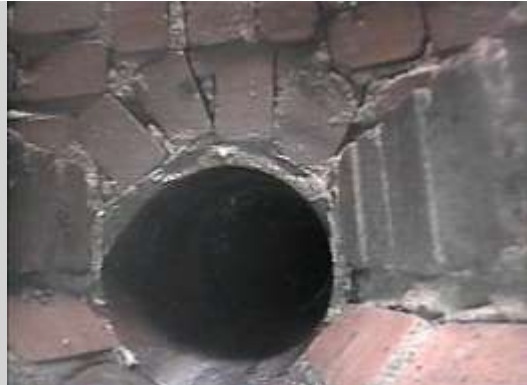
8 in. Circular Gravity Sewer Pipe Out @ 12 O'Clock

Barrel deterioration and infiltration. Channel deterioration.

Infiltration: **Evidence** Pipe Seal Cond: **Unknown**

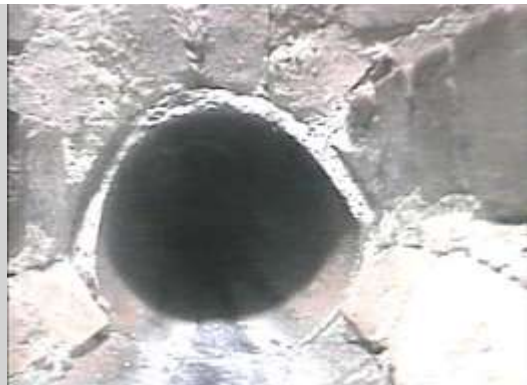
8 in. Circular Gravity Sewer Pipe In @ 4 O'Clock

Barrel deterioration and infiltration. Channel deterioration.
